Conservation Treatment Record
1850s Barège Rural Wedding Dress
Fairlynch Museum

March 2018

Client: Fairlynch Museum
Contact: Betty Hebditch
Object name: Rural wedding dress
Accession number: 1998.145.1

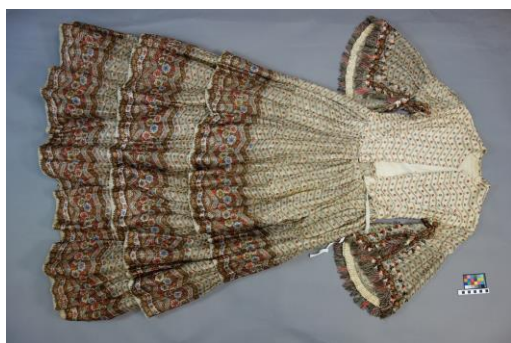
Front before conservation (BT)

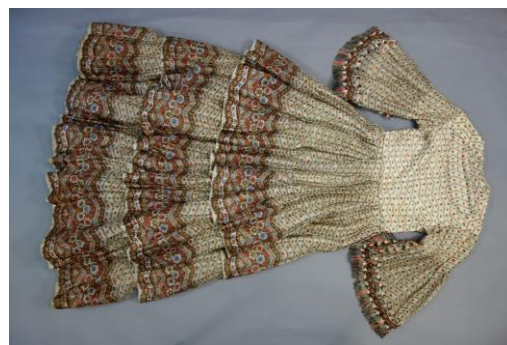
Back BT

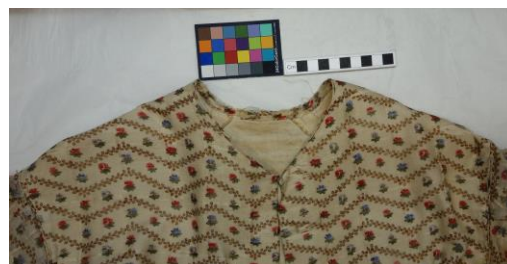
- Major structural damage: there are large splits, holes and loss, particularly at the waist as the bodice and top of skirt cannot bear the weight of the full, flounced skirt. There is a patch repair at the front of the right (proper) side of the bodice where no attempt has been made to match the orientation of the fabric. The piped neckline border has largely lost its outer fabric.

Front neckline with exposed piping and soiling through wear on lining

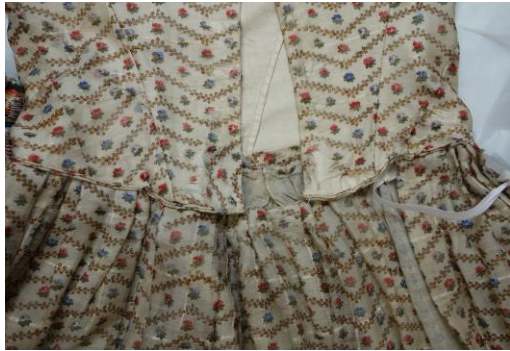
Front waist with damage to bottom of bodice and splits in top of skirt

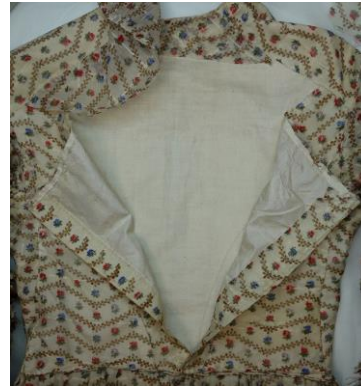
Original silk lined bodice back with lower neckline opened to reveal later linen lining

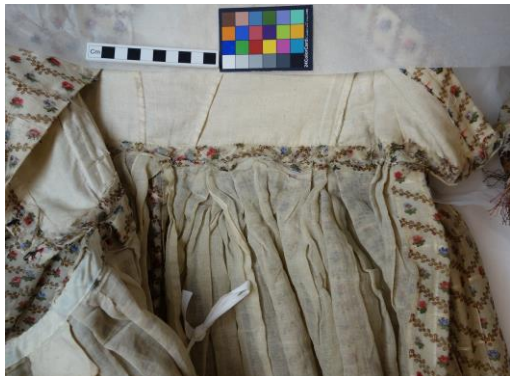
Waist lining and tie which covers small front pocket

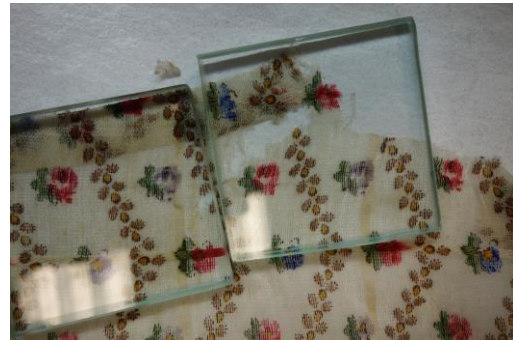
Humidification of second from top patch where damaged, possibly by insects, in progress (IP)

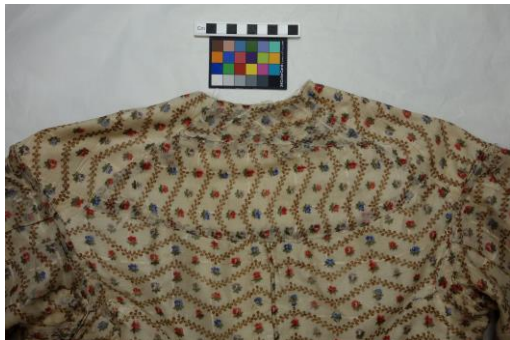
Top back bodice with two panels at the top which do not align with the rest of the fabric and may date from a 19th century alteration BT

When the 1970s stitching was removed from the back the 19th century alterations were uncovered. The two panels making up the high necked back of the altered bodice were misaligned and damaged in places. However, as they made up a substantial part of the bodice and may date from the 19th century they were conserved in situ and not removed. Creases were eased out through humidification using 'Goretex' (semi-permeable membrane) as an intermediate layer between archival blotting paper brushed with deionised water and the textile. Once the creases were eased out they were covered with glass weights to dry. The centre back opening was restitched using fine polyester thread.

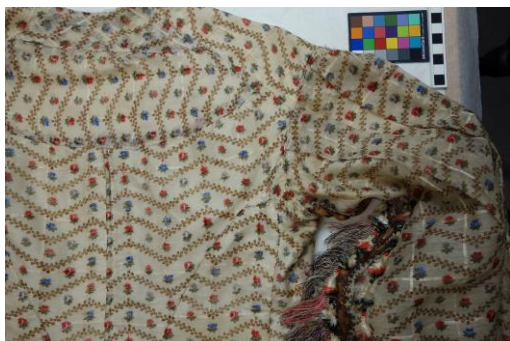
Right back underarm BT

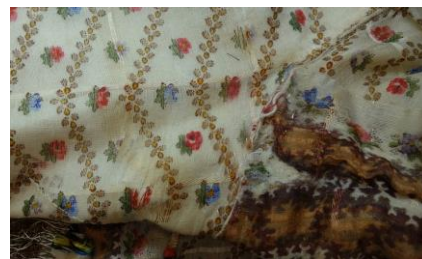
- Minor structural damage: there are also smaller splits and holes in the upper sleeves and throughout much of the bodice, especially concentrated in the underarms. The lining fabrics at the underarms are also in poor condition.

Damage around underarm, exposing piping cord and past stitched repairs

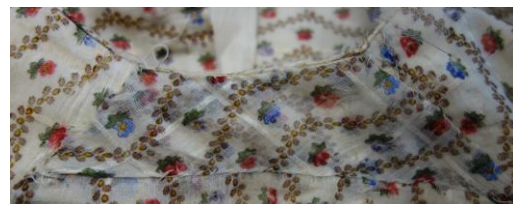
Encasing piping in net

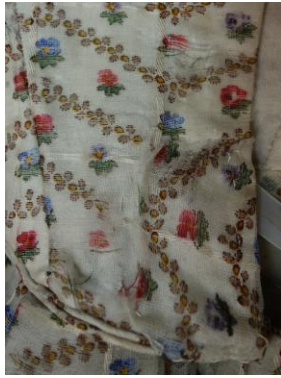
Patch in bottom of front right bodice which does not align with the pattern, IP

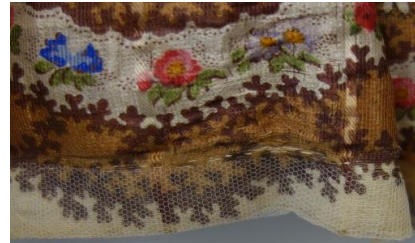
Net applied to flounce hem with earlier repairs above

The splits in the flounces, along the hem and the top of the skirt were supported with a combination of crepe support fabric and nylon net overlays. Previous repairs although not ideal were left in situ as it would have caused significant damage and excessive handling to remove them and replace them with conservation methods and materials.

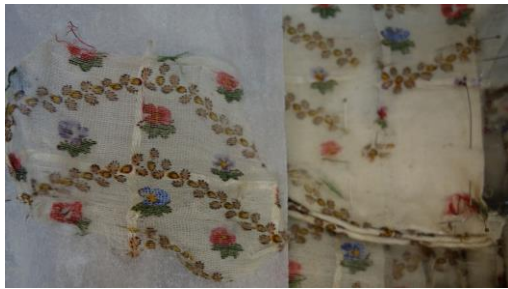
Removed patch leaving lining exposed

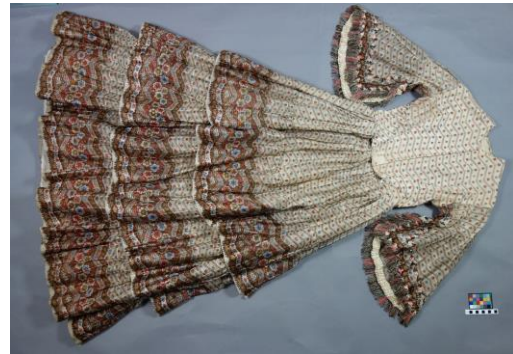
Front after conservation

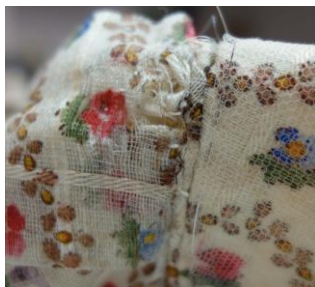
Applying net overlay at bodice shoulder

The underarms and tops of the sleeves were given the same support treatment. An attempt was made to minimise the amount of net used as it does obscure the printed fabric design to some extent. It was only applied to areas that are likely to receive handling during mounting and demounting and those that were clearly weakened. The piped neckline was encased in the nylon net, as were the fragmentary areas of the armhole linings. The splitting at the top of the sleeves was extensive so the long strips of the dyed fine nylon were cut and the narrow band at the top fully covered, following the pleat folds.

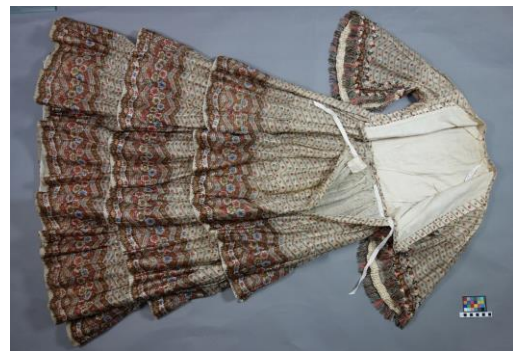
Front open showing linings and new cotton tape ties and small pocket

The inadequate knotted tape at the waistband was removed as was the hook on the left hip as it did not correspond to a loop and was catching on the fragile barège fabric. New, scoured cotton twill tapes were stitched in place along a substantial part of the front and back of the waistband. The front one was stitched under the small pocket so as not to obscure it. The skirt can now be fastened by tying the tapes at the left front.

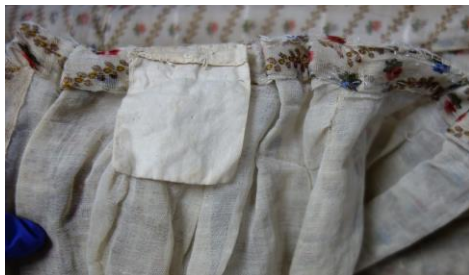
Previous tape removed from waist, revealing small pocket

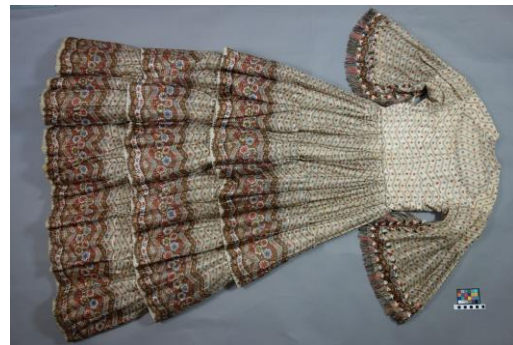
Back after conservation

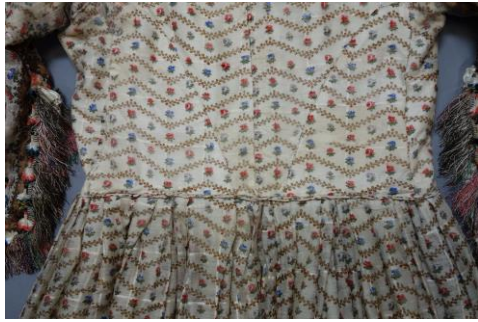
Back waist after conservation

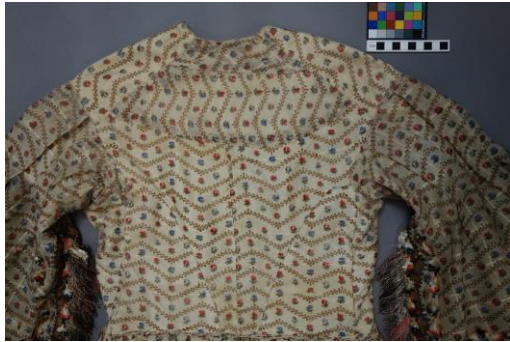
Back bodice and sleeves after conservation
